# Periodic Inspection of Ofu Harbor Breakwater, American Samoa

## Report 1 Base Conditions

by *Robert R. Bottin, WES*  
*Stanley J. Boc, Pacific Ocean Division*

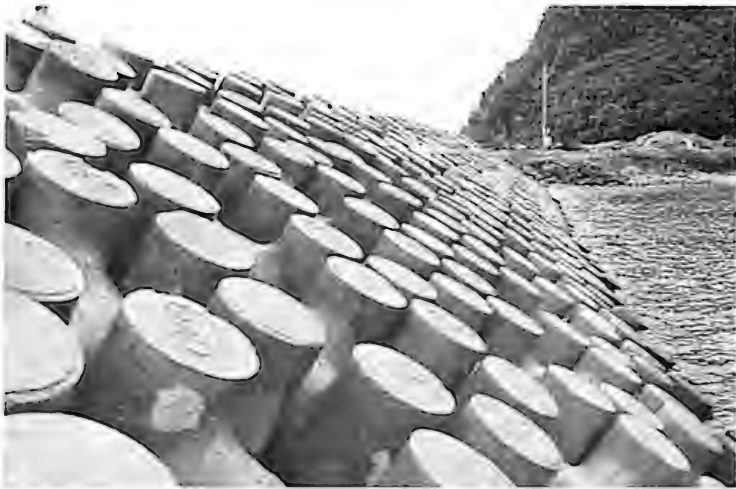
Figure 5. Tribar armor units used on Ofu Harbor breakwater

The breakwater armor consisted of a single layer of uniformly placed 4,080-kg (4.5-ton) concrete tribar units (Figure 5). The tribars originated at sta 1+75 on the seaward face of the structure and extended to sta 6+00, around the head, and then to sta 4+00 on the harbor side of the breakwater. To improve the stability of the tribars, work included the construction of a toe trench in order to stabilize the armor unit toe, and a concrete rib cap system on the breakwater crest to stabilize and buttress tribars at the upper sea-side and harbor-side slopes. The rib cap forms were fabricated and concrete poured right into the top section of the tribars (Figure 6). The crest elevation of the rib cap was +4.6 m (+15 ft), and the slope of the structure was 1V:1.5H.

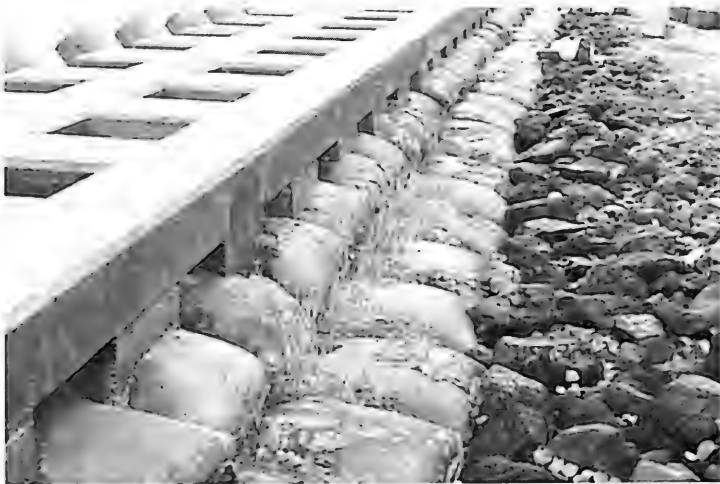
Figure 8. 2,270-kg (2.5-ton) high-strength concrete units used on harbor side of structure

In addition to the “swiss cheese block” underlayer unit, both 2,270-kg and 510-kg (2.5-ton and 1,125-lb) concrete units were formed by pumping high-strength, fine-aggregate concrete into geotextile fabric bags. The 2,270-kg (2.5-ton) units were used as a rib cap underlayer and were placed along the landfill on the harbor side of the structure between stas 1+75 and 4+00 (Figure 8). These units measured approximately  $1.4 \times 0.9 \times 0.8$  m ( $4.5 \times 3.0 \times 2.5$  ft) in size.

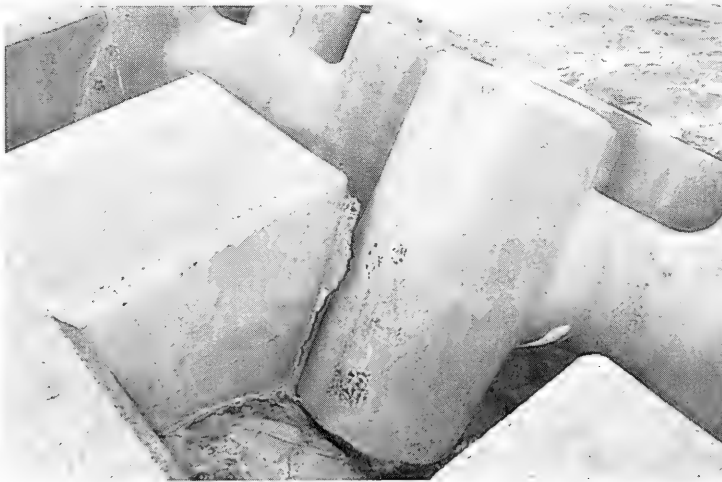
On 16 October 1996, a walking survey of armor units above the waterline was conducted on the outer 130-m (425-ft) portion of the Ofu Harbor breakwater. The survey of the structure revealed no broken tribars. One sea-side tribar was slightly separated from the rib cap (Figure 11) at sta 3+05. On the

Figure 11. Separation between tribar and rib cap
